1. Report No. SSRP-2001/25	2. Government Accession No.	3. Recipient's Catalog No.	
4. Title and Subtitle SEISMIC DESIGN AND PERFORMANCE OF PRECAST CONCRETE SEGMENTAL BRIDGE COLUMNS		5. Report Date May 2002

6. Performing Organization Code	
7. Author(s) Joshua T. Hewes and M. J. Nigel Priestley		8. Performing Organization Report No. UCSD / SSRP-2001/25	
9. Performing Organization Name and Address  Department of Structural Engineering School of Engineering University of California, San Diego La Jolla, California 92093-0085		10. Work Unit No. (TRAIS)

This research involved the investigation of the performance of unbonded post-tensioned precast concrete segmental bridge columns under lateral earthquake loading. Two columns with a high aspect ratio and two columns with a low aspect ratio were tested under simulated lateral seismic loading. Steel jackets of different thickness were used to confine the plastic end region at the base of each column. The specimens all contained the same amount of prestressing steel and each was tested twice: the first time with a relatively low initial tendon stress, and the second with a higher initial prestress level. An analytical model describing the c

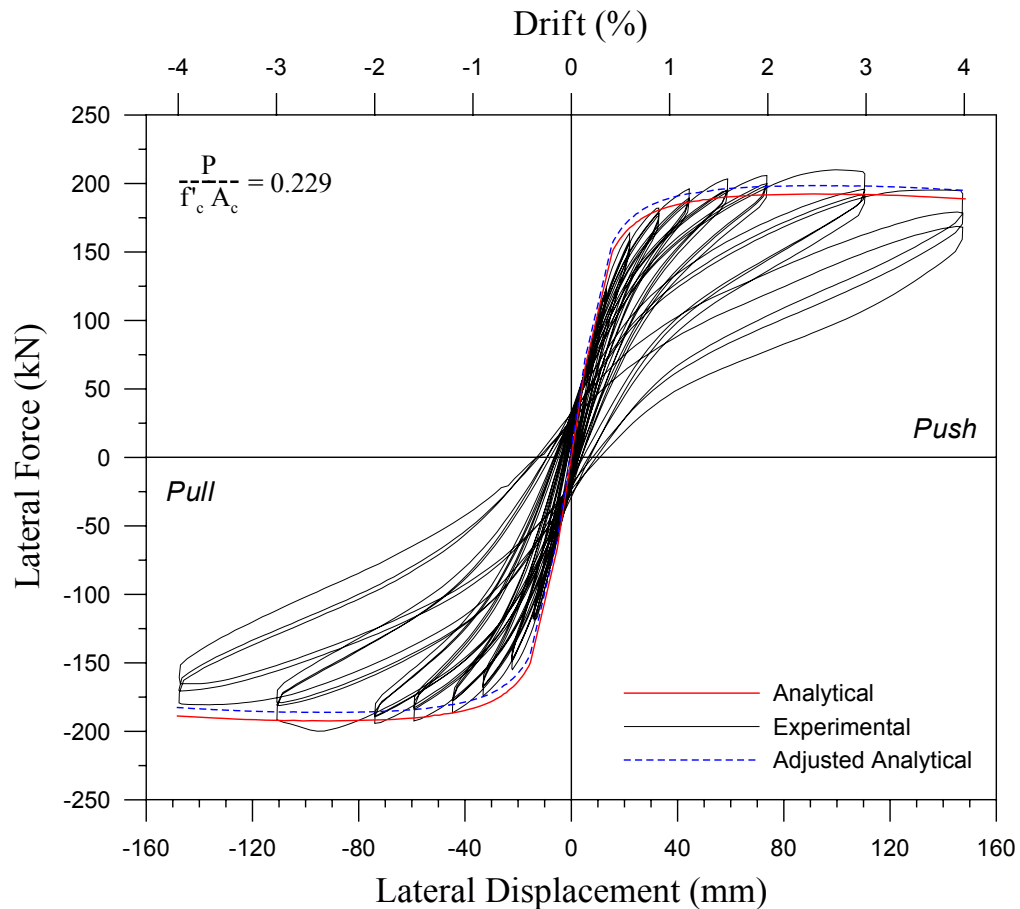
Figure 4.62 JH2 – Test 1 Force-displacement response

The lateral force-displacement response of the column for the first test is shown in Figure 4.62. The specimen exhibited stable and symmetric hysteretic behavior up to the maximum imposed drift of 4.0%. Significant non-linear response initiated at a force of 160 kN, or approximately  $2.5 \times P_1$ . The maximum column strengths for the push and pull loading directions were 206.9 kN and  $-194.2$  kN, and occurred at drifts of 3.0% and 2.0%, respectively. Degradation of the column strength was not dramatic, with capacities at the 4.0% drift approximately 7% lower than the maximum observed values.

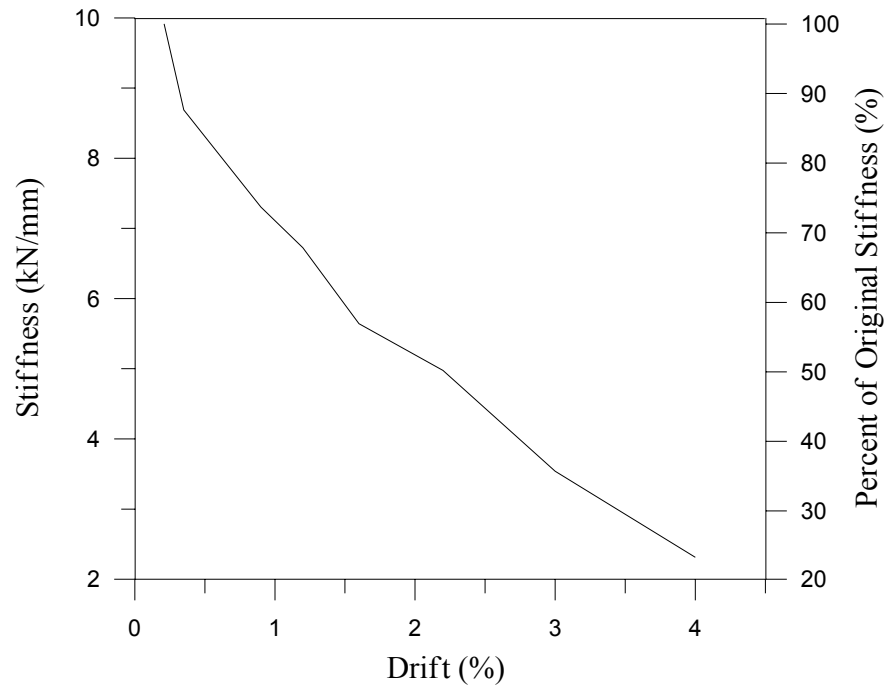
Figure 4.63 JH2 – Test 1 Initial loading stiffness versus drift

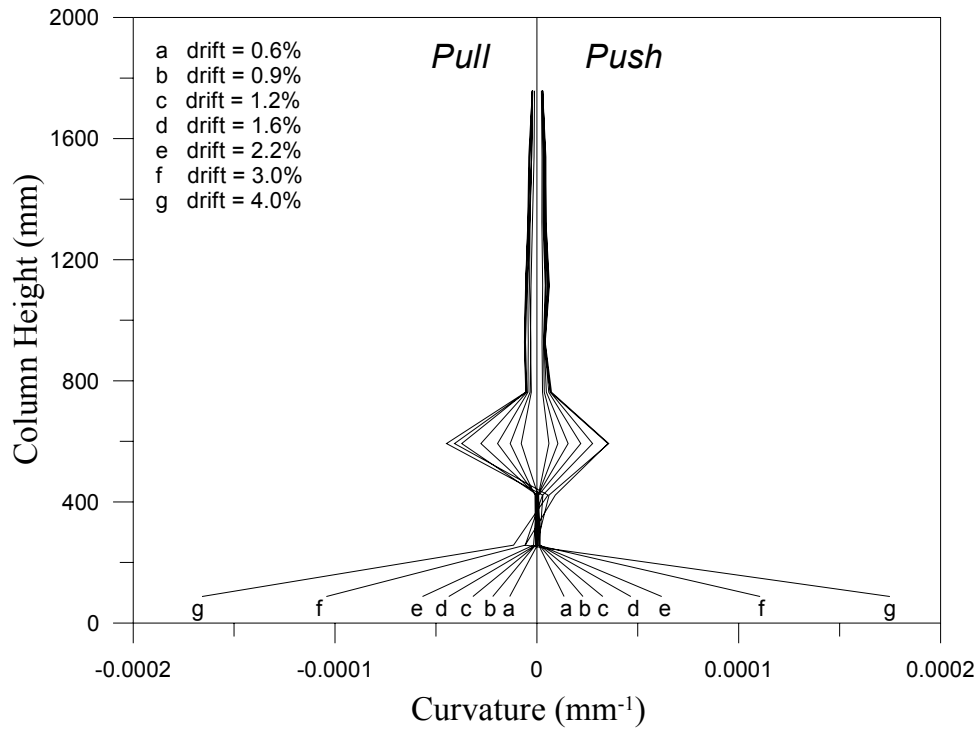
Figure 4.65 JH2 – Test 1 Curvature along column height

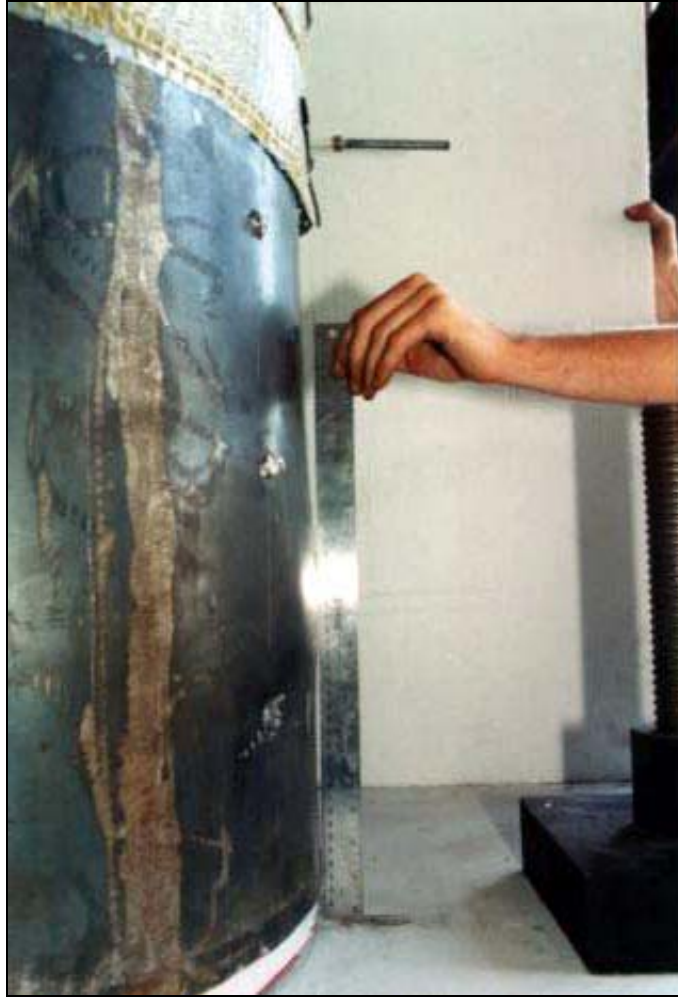
Figure 4.77 JH2 – Test 2 Bulge in steel jacket at north generator after testing

A photo of steel jacket at the north generator taken after testing is shown in Figure 4.77. A bulge at mid-height of the jacket is visible. The lower half of the jacket is noticeably ‘belled’ due to the severe hoop straining at the critical section. The residual drift of the column at the end of the test was on the order of 0.7%. Part of this was due to the translation of the column base with respect to the footing noted above. As was the case for the first test, significant damage was observed below the jacket due to the high longitudinal compressive strains at the compression toe of the column. No damage was observed in the column segments above the steel jacket other than the minor flexural cracks detailed above. No inclination of cracks was observed, and all cracks – except for the crack at the base of the column – closed completely once the lateral force was removed from the column. A residual crack at the column base existed at each loading generator due to the deformed epoxy and crushed concrete. As noted, significant deformation of the steel jacket was observed for cycles at high drift levels. The prestressing steel did not fracture during testing.

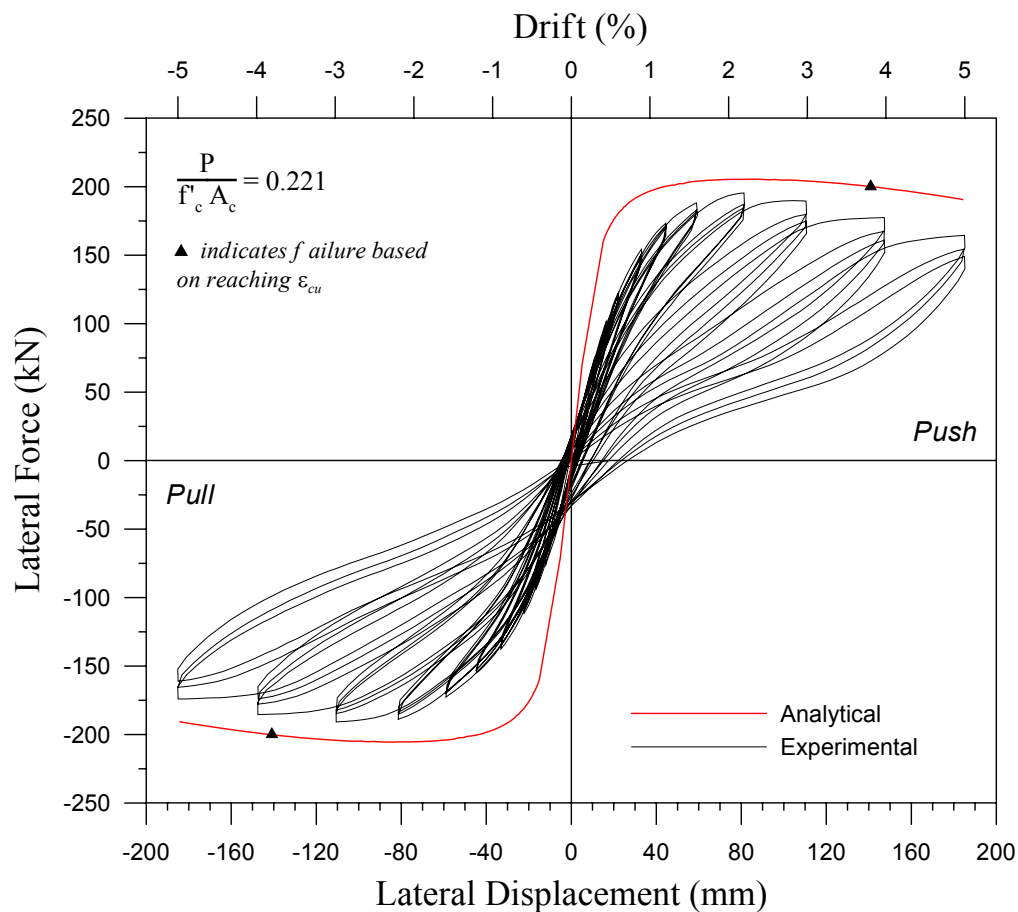
Figure 4.78 JH2 – Test 2 Force-displacement response

The second test lateral force-displacement response of specimen JH2 is shown in Figure 4.78. Stable hysteretic response was observed during the test, up to the maximum imposed drift of 5.0%. Approximately equal strengths were achieved for the two loading directions. Significant non-linear response initiated at around 170 kN. This force level corresponds to approximately  $2.4 \times P_1$ . The maximum column strengths were 195.4 kN and -190.8 kN for the push and pull directions, respectively. The maximum strength for the push direction occurred at a drift of 2.2%, while that for the pull direction was observed at 3.0% drift. At a drift of 5.0%, the column strength had decreased to 16% and 8 % of the maximum achieved strength for the push and pull directions, respectively.

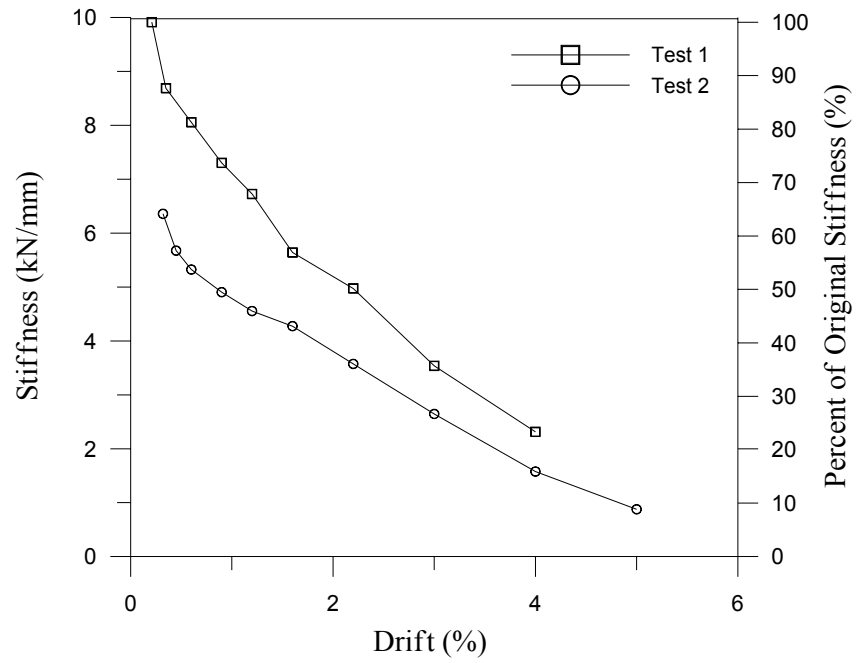
Figure 4.79 JH2 – Test 2 Initial loading stiffness versus drift

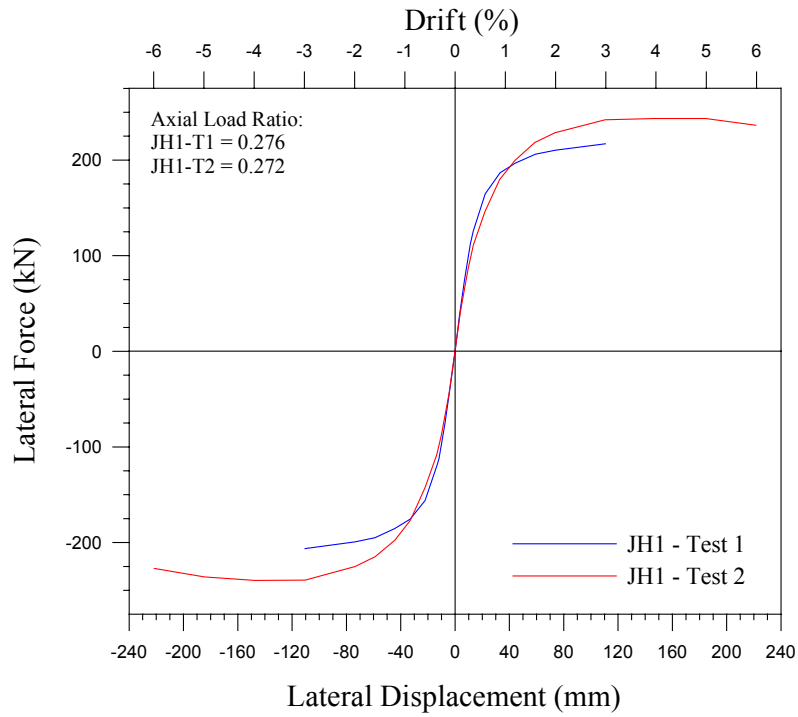
Figure 4.95 JH1 - Test 1 and 2 force-displacement response comparison

The force-displacement response for the first and second test of unit JH1 are shown in Figure 4.95. While the total prestress force for the second test was approximately 22% higher than that for the first test, the maximum observed strength was only about 14% higher than the strength for the first test. It should be noted that despite the higher prestress force, the axial load ratio was actually lower for the second test since the concrete continued to gain strength during the time between the first and second tests. The experimental response for the two tests of unit JH2 are shown in Figure 4.96. The prestress force for the second test was about 21% higher than that for the first test, but the maximum observed second test strength was actually 5% less than that for the first. It is believed that the damage to the core concrete within the steel jacket was significant for the first test and thus adversely affected the second test performance of JH2. Confinement of the core concrete by the steel jacket near the column base may have been compromised for the second test due to the large inelastic hoop straining of the jacket observed for the first test.

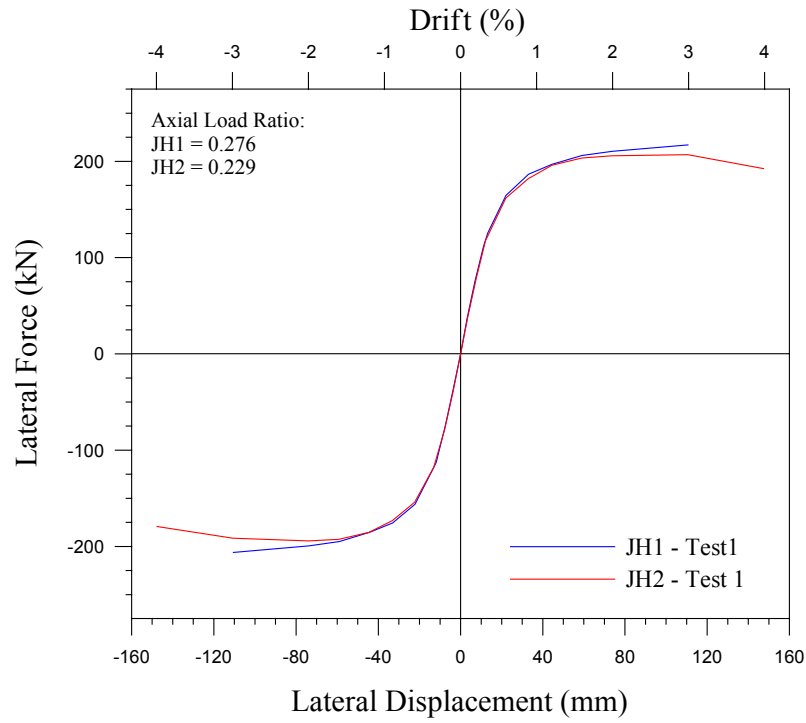
Figure 4.97 JH1 and JH2 Test 1 force-displacement response comparison

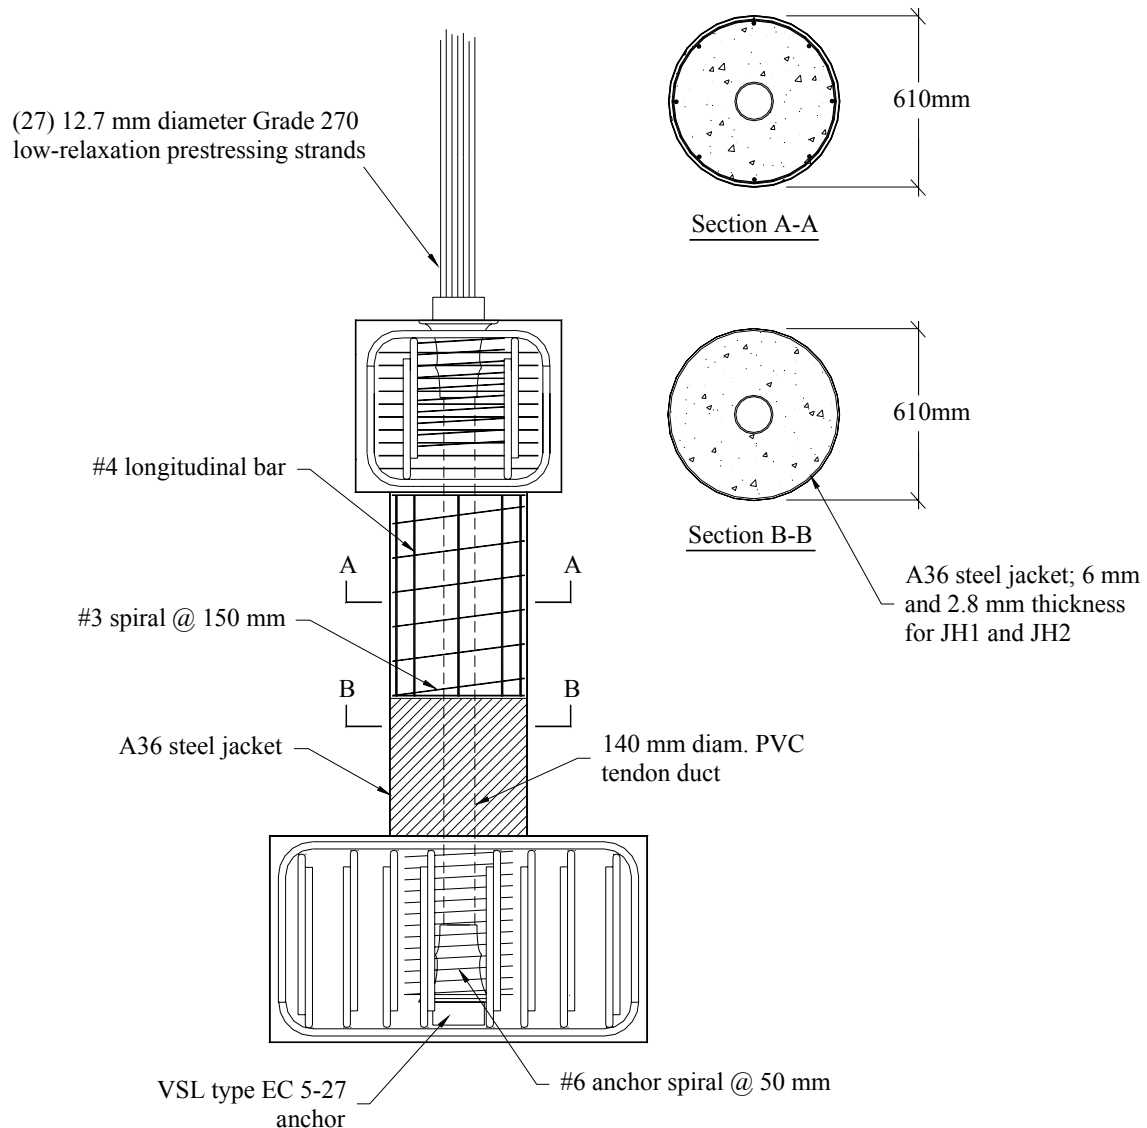
Figure 5.1 Test unit JH3 and JH4 reinforcement details

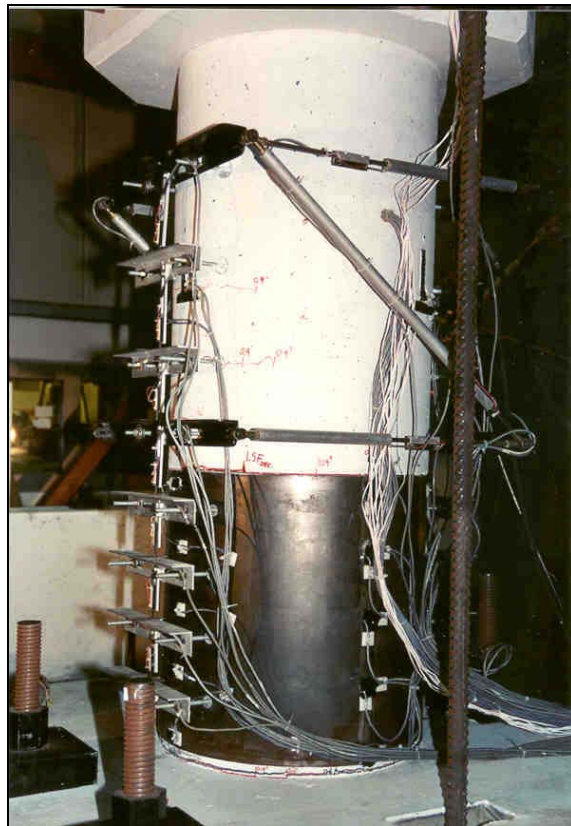
Figure 5.9 JH3 – Test 1 Column at -1.6% total drift

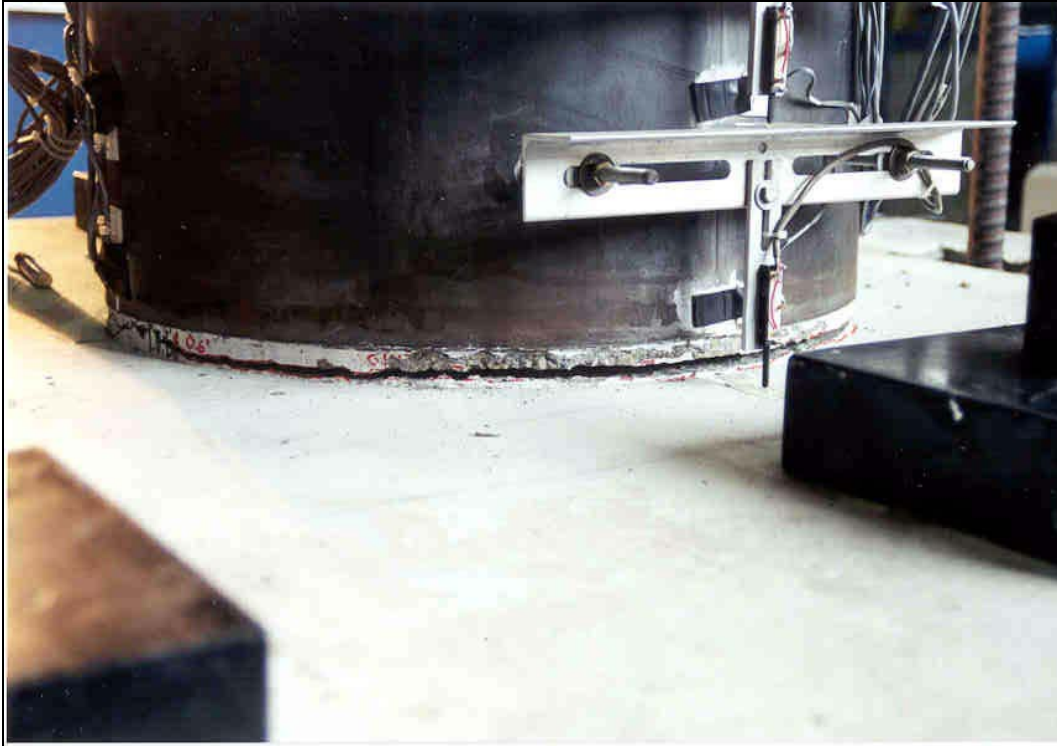
Figure 5.10 JH3 – Test 1 Damaged region below jacket at 2.2% drift

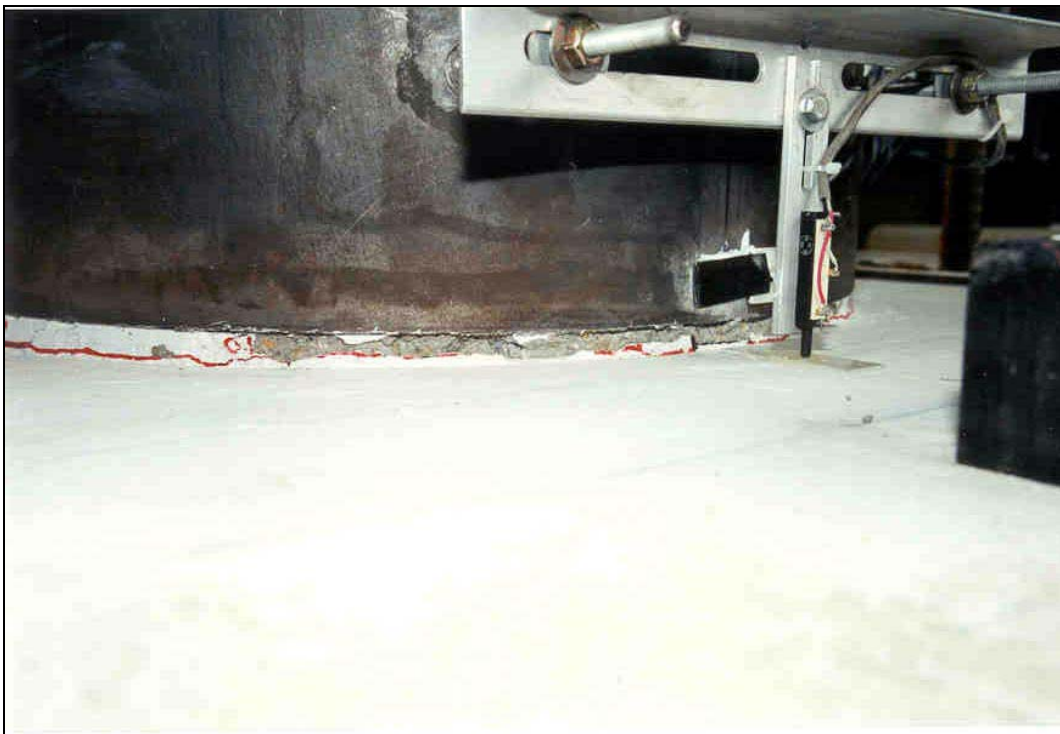
Figure 5.11 JH3 – Test 1 Close-up of damage at compression toe of column at 3.0% drift

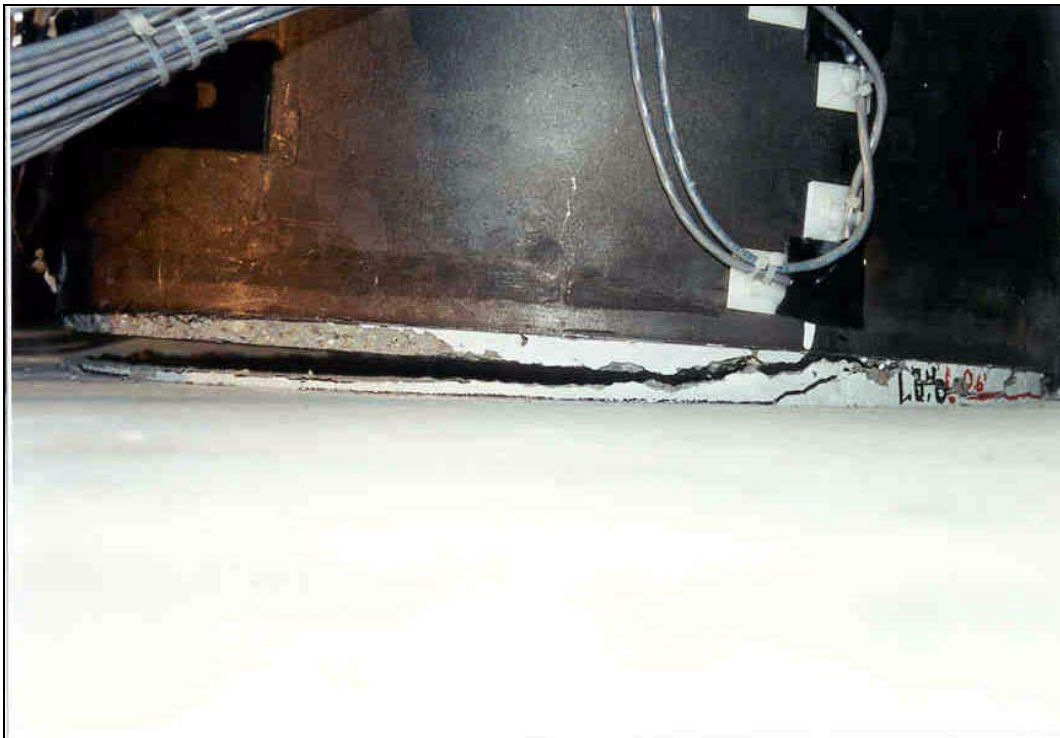
Figure 5.12 JH3 – Test 1 Base crack opening at 4.0% total drift

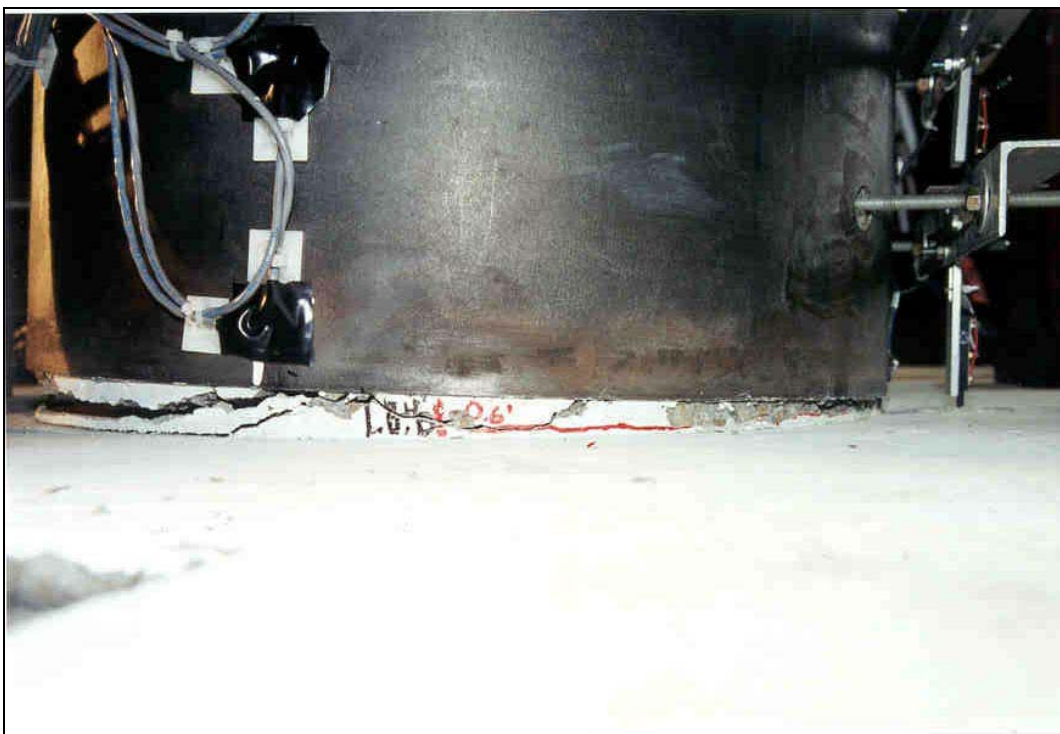
Figure 5.13 JH3 – Test 1 Base crack and crushed region below jacket at 4.0% drift

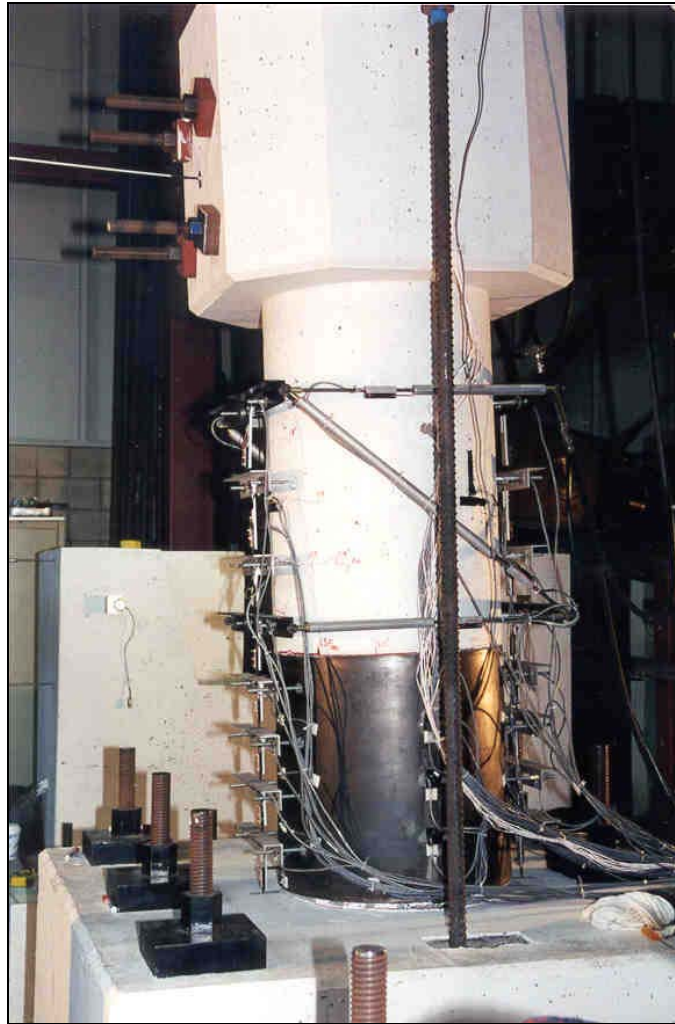
Figure 5.14 JH3 – Test 1 Column during third push cycle at 4.0% drift

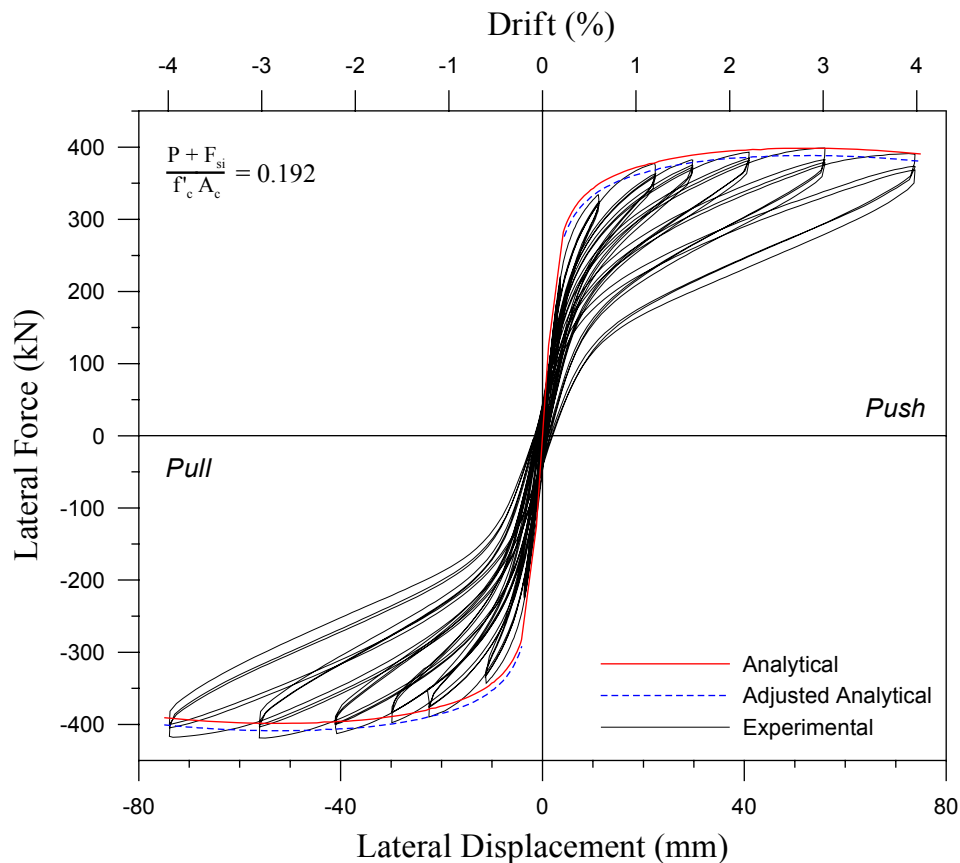
Figure 5.15 JH3 – Test 1 Force-displacement response

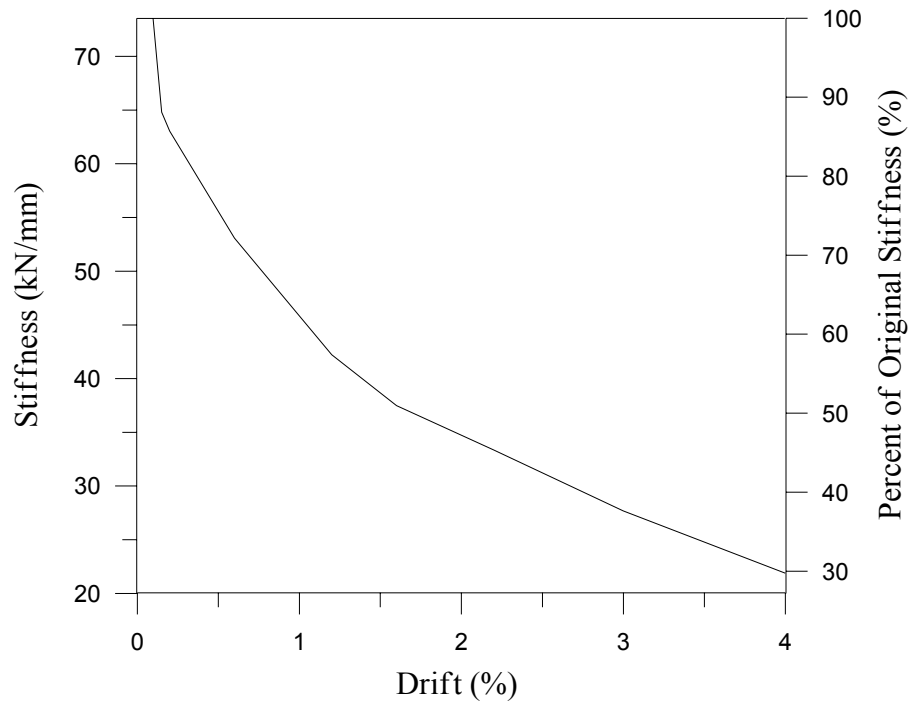
Figure 5.16 JH3 –Test 1 Initial loading stiffness versus drift

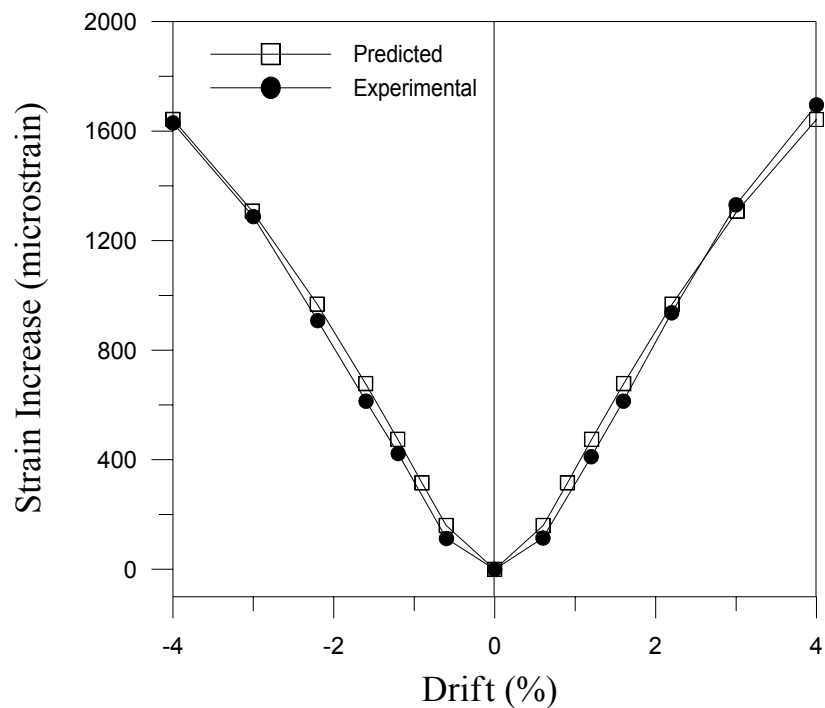
Figure 5.19 JH3 – Test1 Predicted and Experimental Tendon Strain Increase

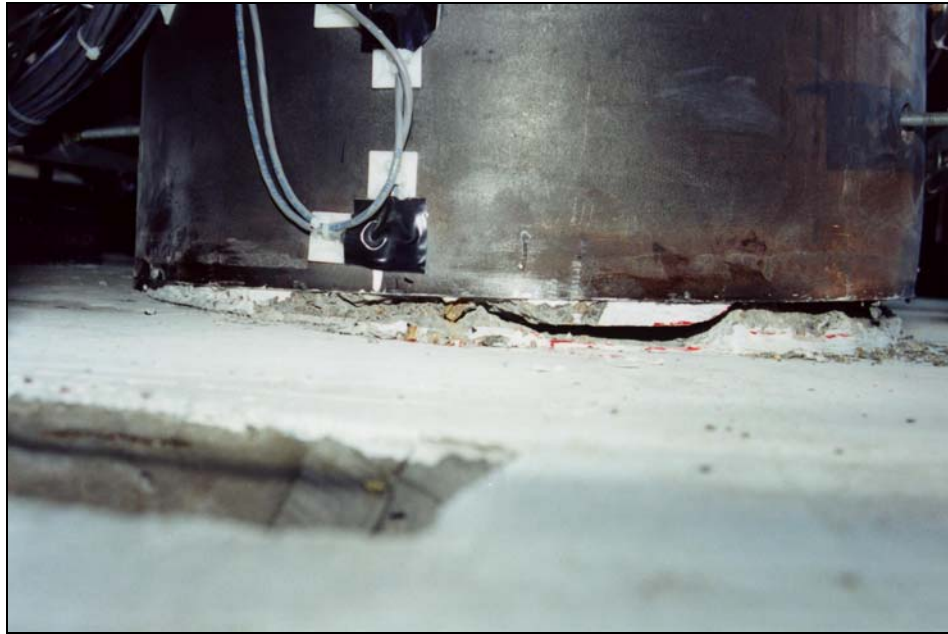
Figure 5.30 JH3 –Test 2 View of east generator below jacket at 6.0% drift

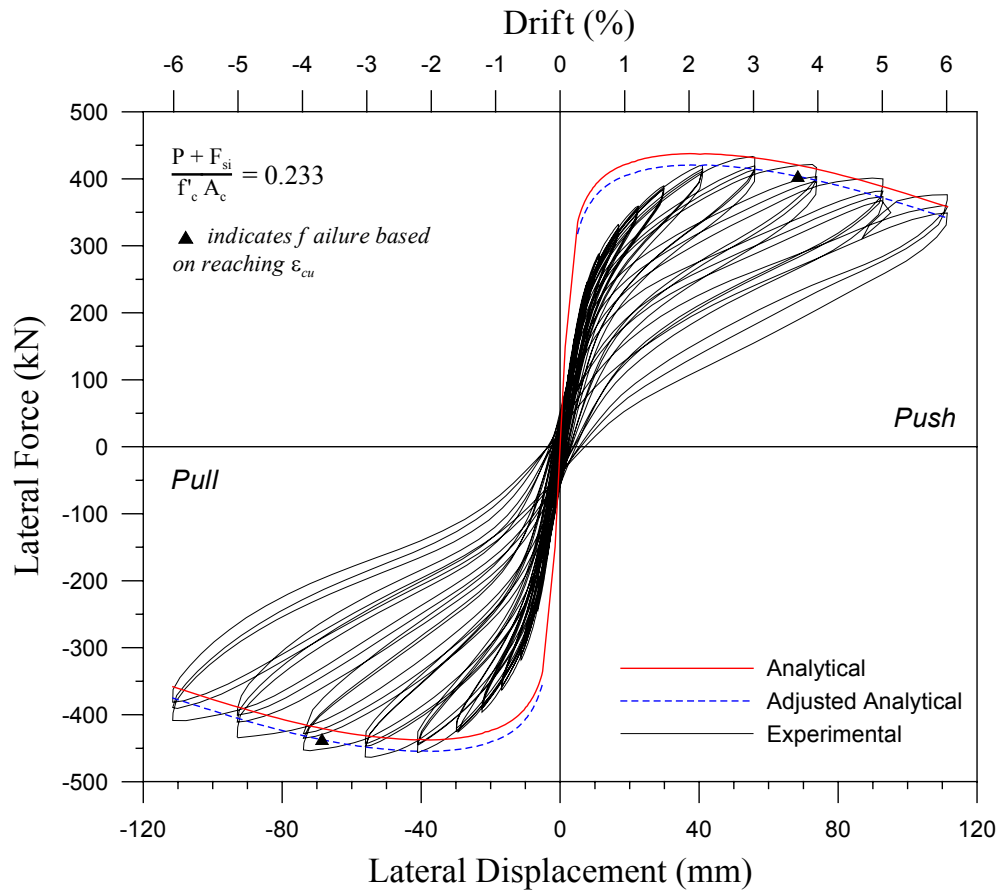
Figure 5.32 JH3 – Test 2 Force-displacement response

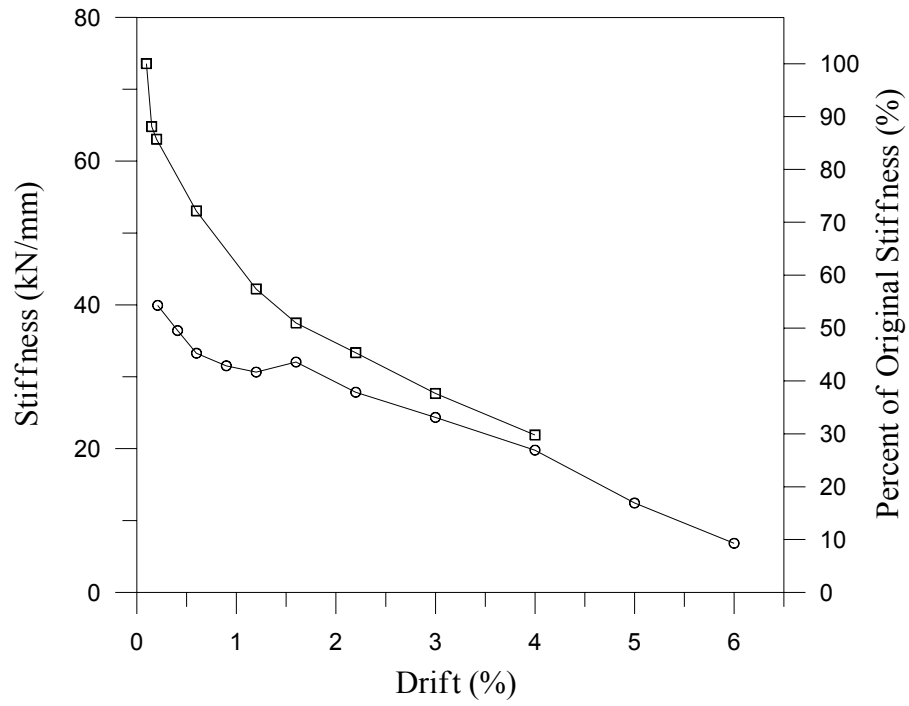
Figure 5.33 JH3 – Test 2 Initial loading stiffness versus drift

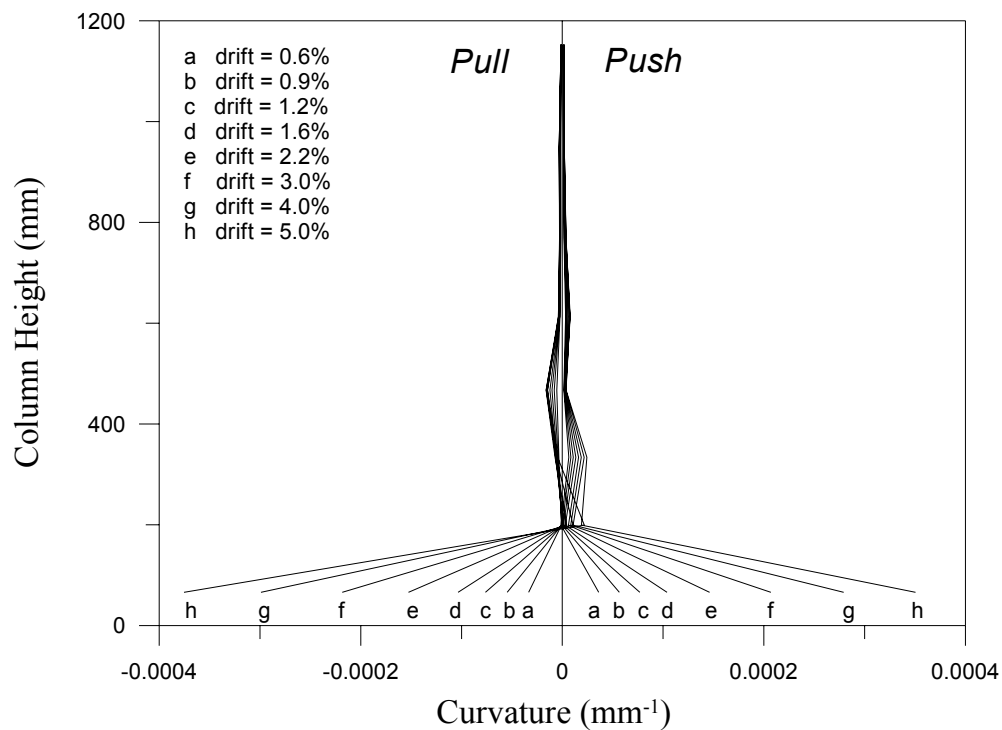
Figure 5.35 JH3 – Test 2 Curvature along column height

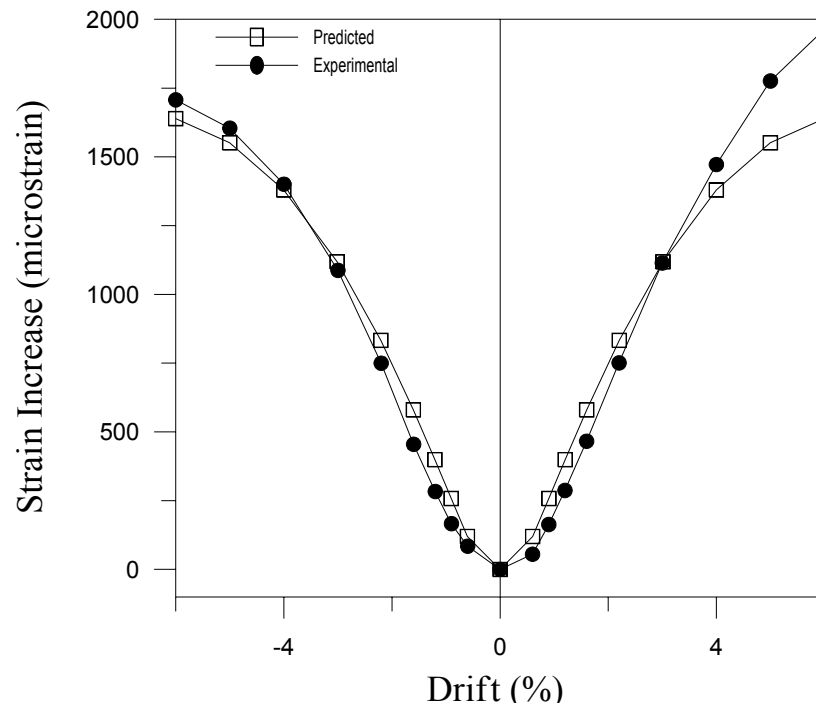
Figure 5.36 JH3 – Test 2 Predicted and experimental tendon strain increase

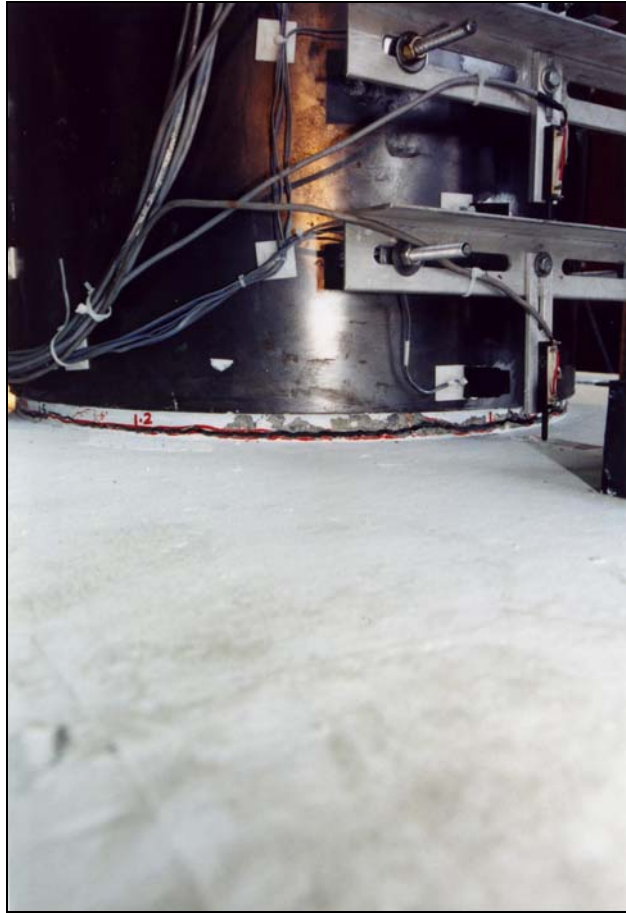
Figure 5.47 JH4 – Test 1 Crack at column base at 1.6% drift

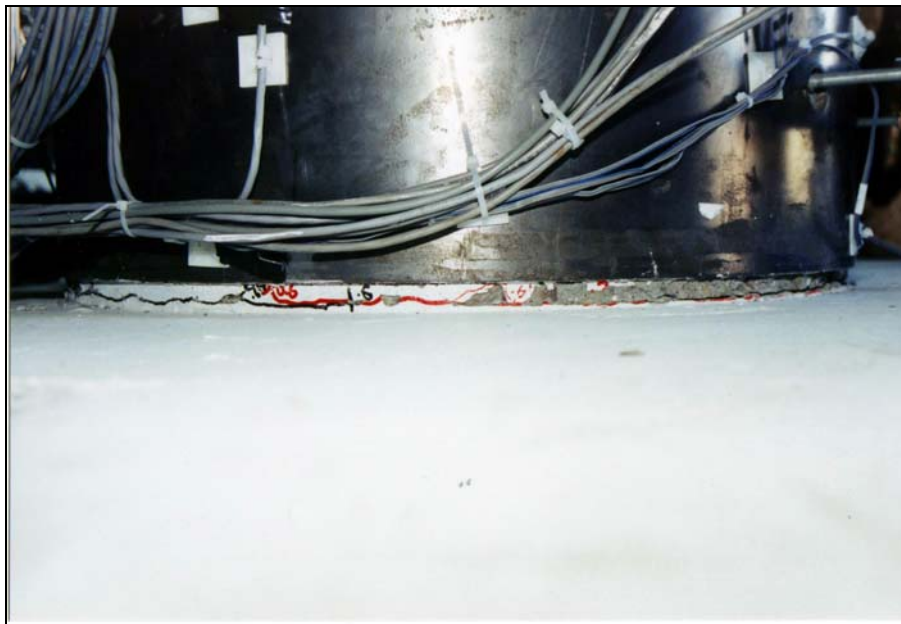
Figure 5.48 JH4 – Test 1 Crack at column base and damaged region at 4.0% drift

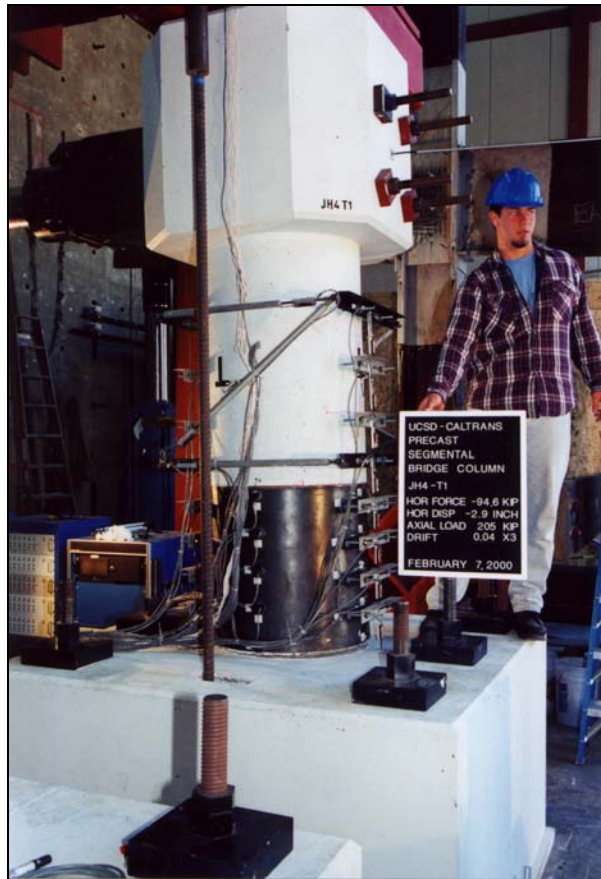
Figure 5.49 JH4 – Test 1 Overall view of specimen at 4.0% drift

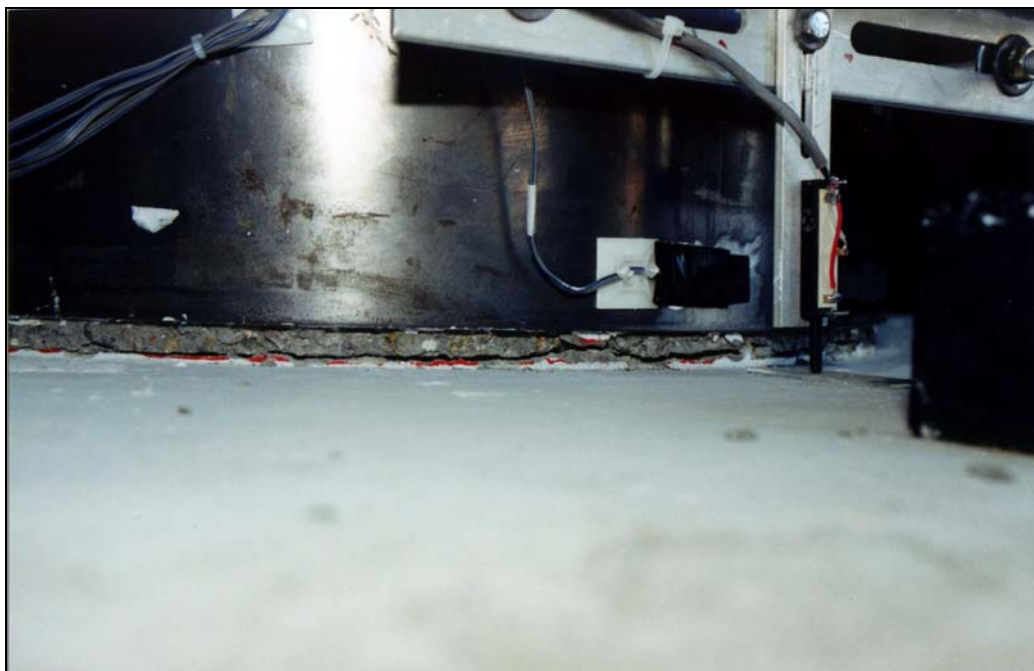
Figure 5.50 JH4 – Test 1 Close-up of damaged region below jacket at test end

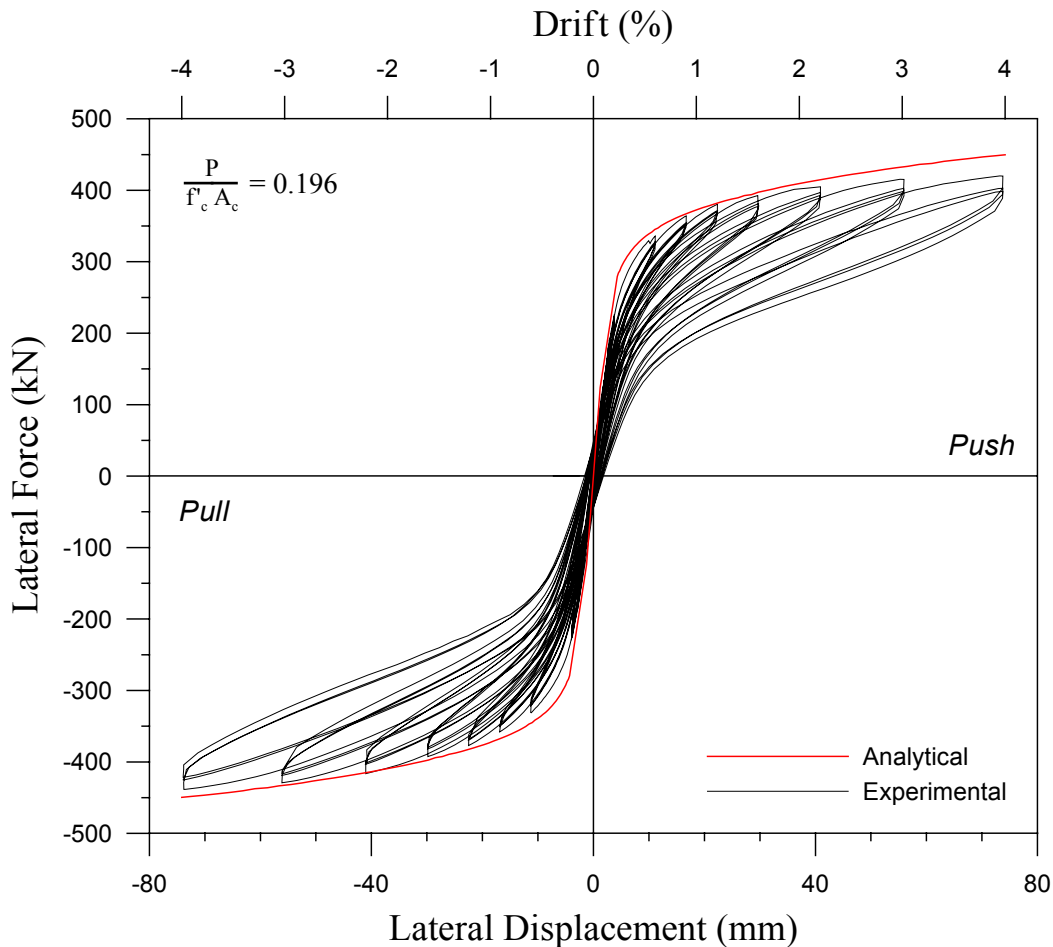
Figure 5.51 JH4 – Test 1 Force-displacement response

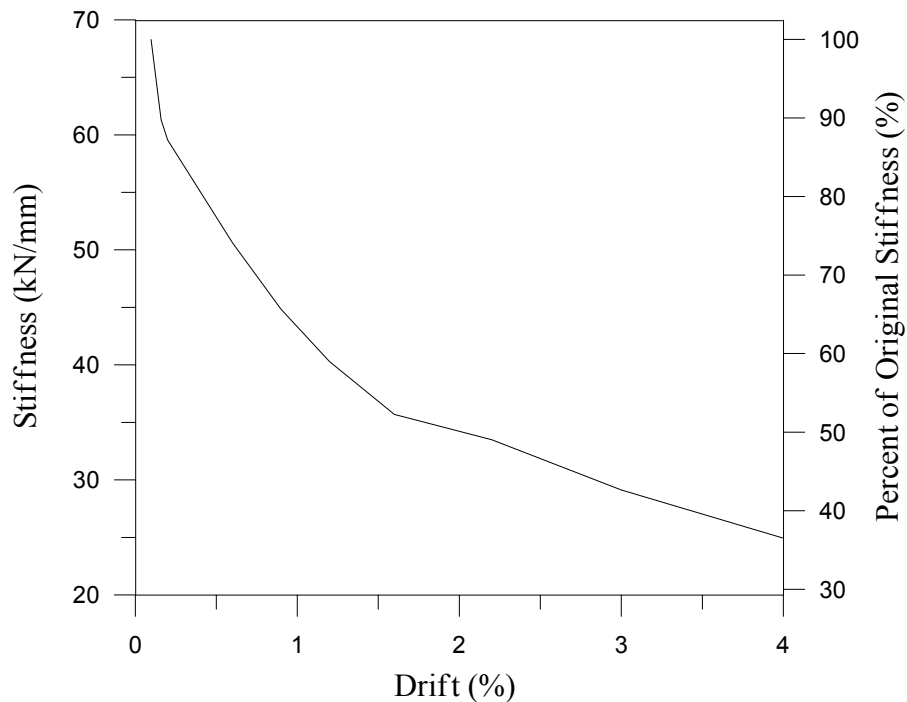
Figure 5.52 JH4 – Test 1 Initial loading stiffness versus drift
